September 5, 2023

Malik Tamimi
Senior CIP Project Manager
Rainbow Municipal Water District
3707 Old Hwy 395, Fallbrook, CA 92028
T: 760-728-1178, ext. 173

RE: Moody Property Bridge Assessment – Technical Memorandum

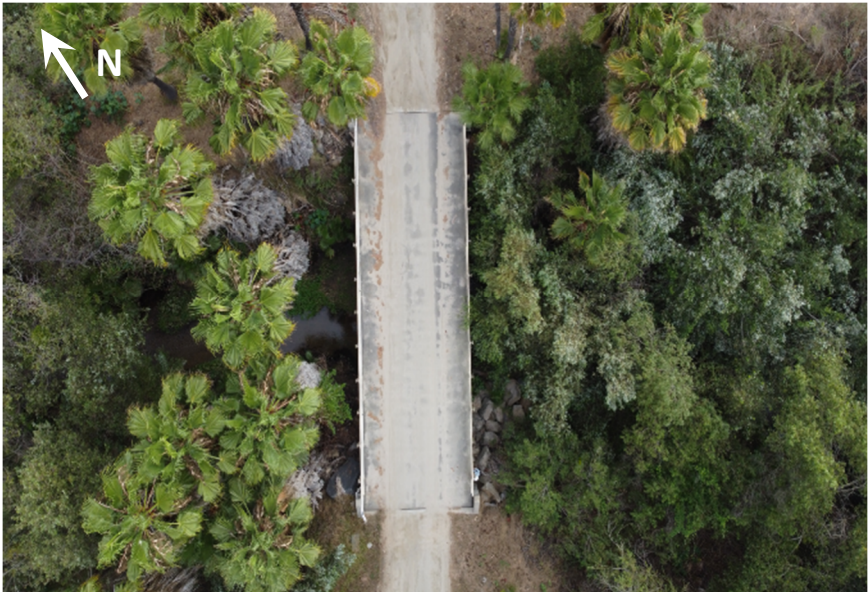
Figure 2 – Enlarged view of the bridge taken by drone during the PSE inspection

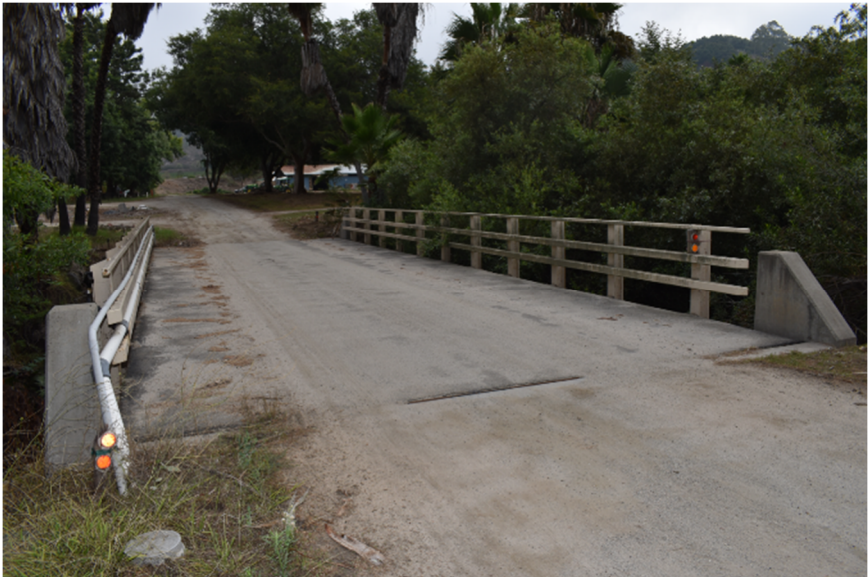
Photograph 1 – Ground-level view of drivable surface

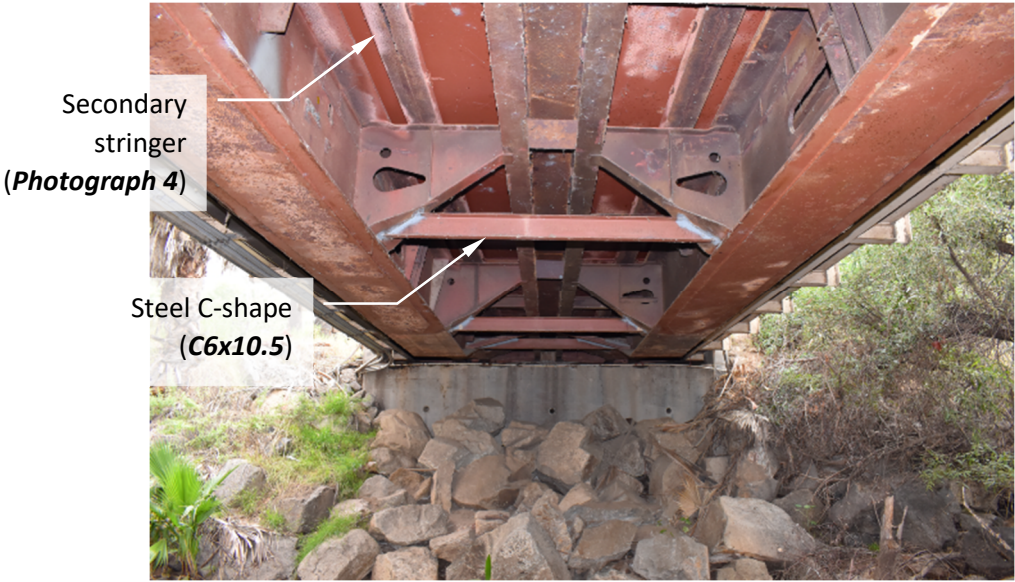
Photograph 2 – Underside of the bridge

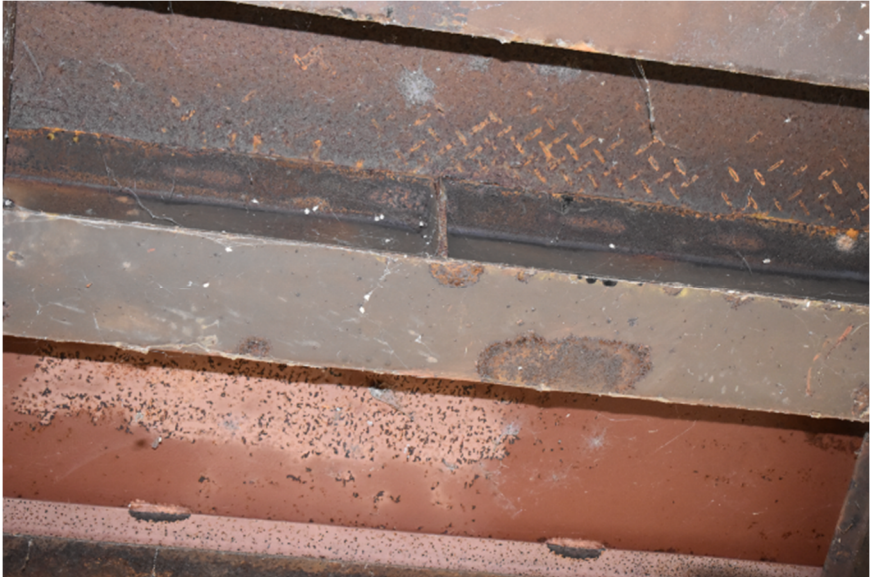
Photograph 3 – Minor stains and discoloration

Based on visual observations, bridge framing did not appear deflected at the time of the site visit. As noted in the photographs, stains, surface corrosion of secondary stringers, and instances of discoloration were present at various locations along the length of this 20+ year-old bridge. These types of minor deteriorations are normal for a bridge of this age located over a creek. Furthermore, the main load carrying structural members of the bridge structure were intact, and no indications of section loss were present. Therefore, it is PSE’s opinion that the overall structural integrity of the bridge is good and serviceability is intact.

4. PSE recommends that the bridge be visually inspected every two to four years by a California licensed civil professional engineer (PE) or structural engineer (SE) for continued use and to maintain the recommended load limit.

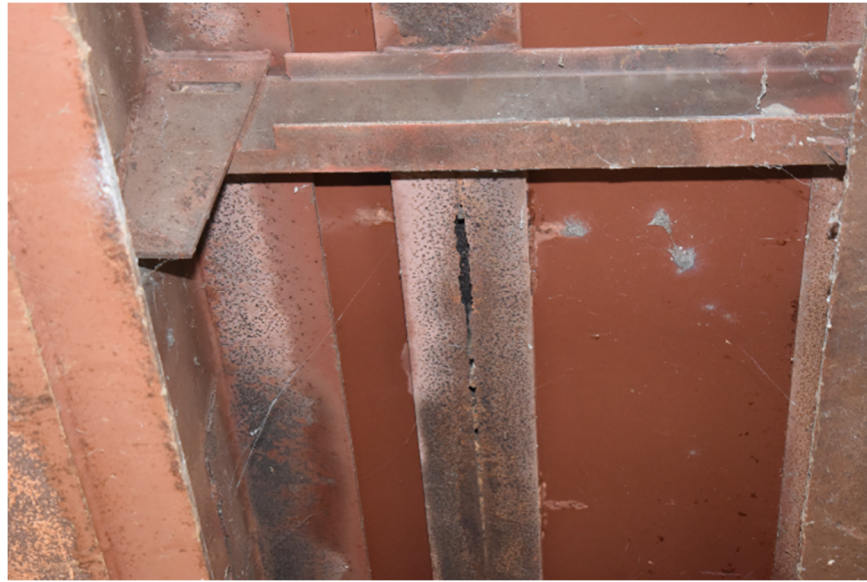
Photograph 4 – Surface corrosion of secondary stringers

1. The overall structural integrity and serviceability of the bridge appears to be acceptable. PSE believes that observed minor stains, discoloration, and corrosion of secondary stringers does not significantly affect the ability of the bridge to carry loads.
2. It is PSE’s professional opinion that the current capacity of the bridge is sufficient to handle the HS20-44 design loading as specified in the as-built drawings.
3. The demands imposed by the proposed 128,000-pound transport vehicle are within +/- 5% of the demands imposed by the design vehicle, therefore the bridge appears to have sufficient capacity to support the design vehicle. The design vehicle should cross the bridge slowly as to not impart dynamic forces and the 128,000-pound vehicle loading should not be exceeded.

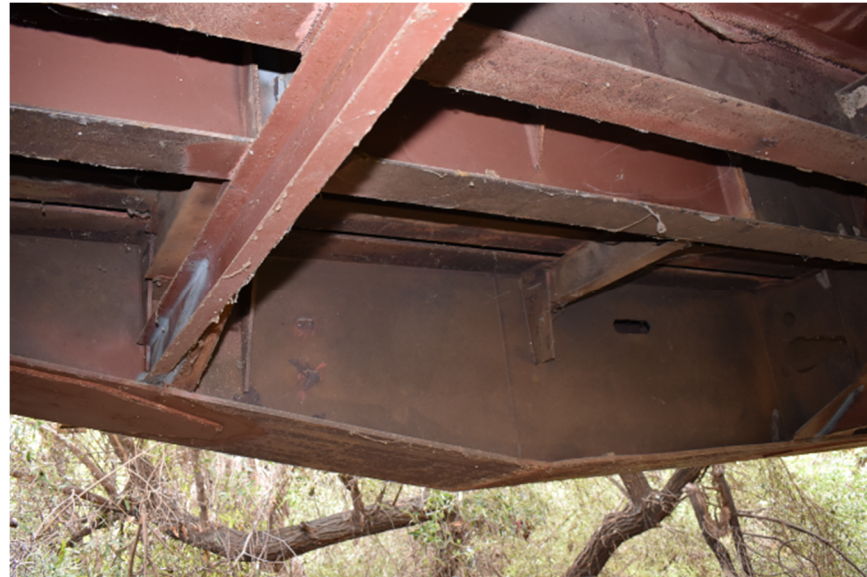
Photograph 5 – Structural members intact and undeflected

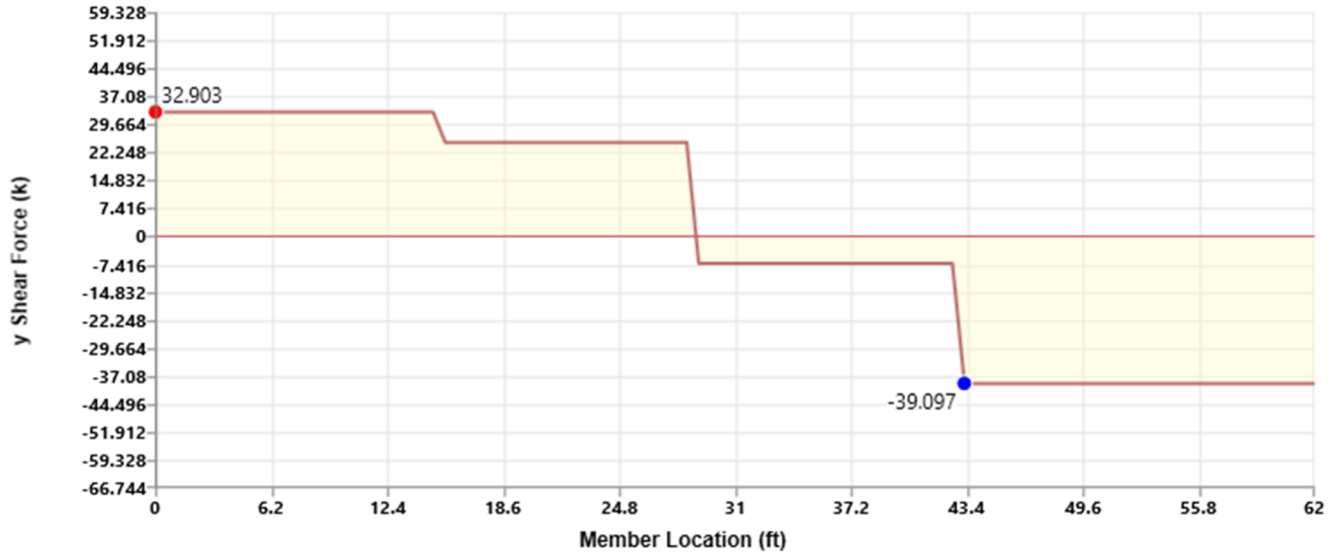
PSE used RISA 3D software to determine the worst-case shear and moment demand load envelopes for the two configurations described above. Figures 3 through 6 below illustrate the outcome of this software analysis; Table 2 provides a direct comparison of the demands associated with each of the two configurations.

Figure 3 – Envelope shear diagram – HS20-44 loading

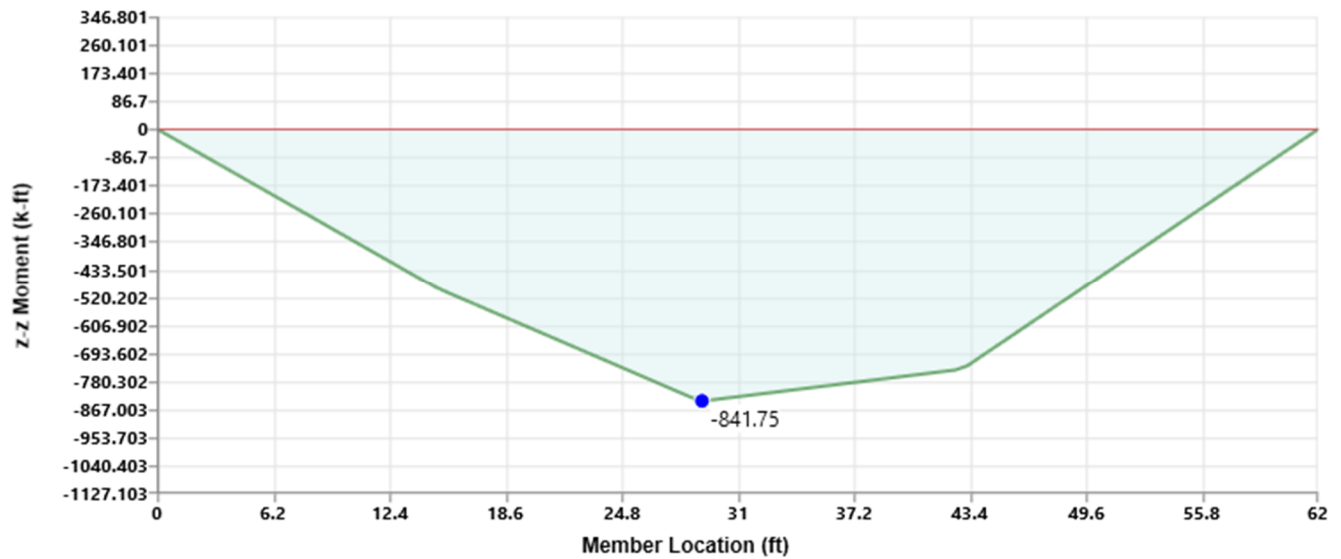
Figure 4 – Envelope moment diagram – HS20-44 loading

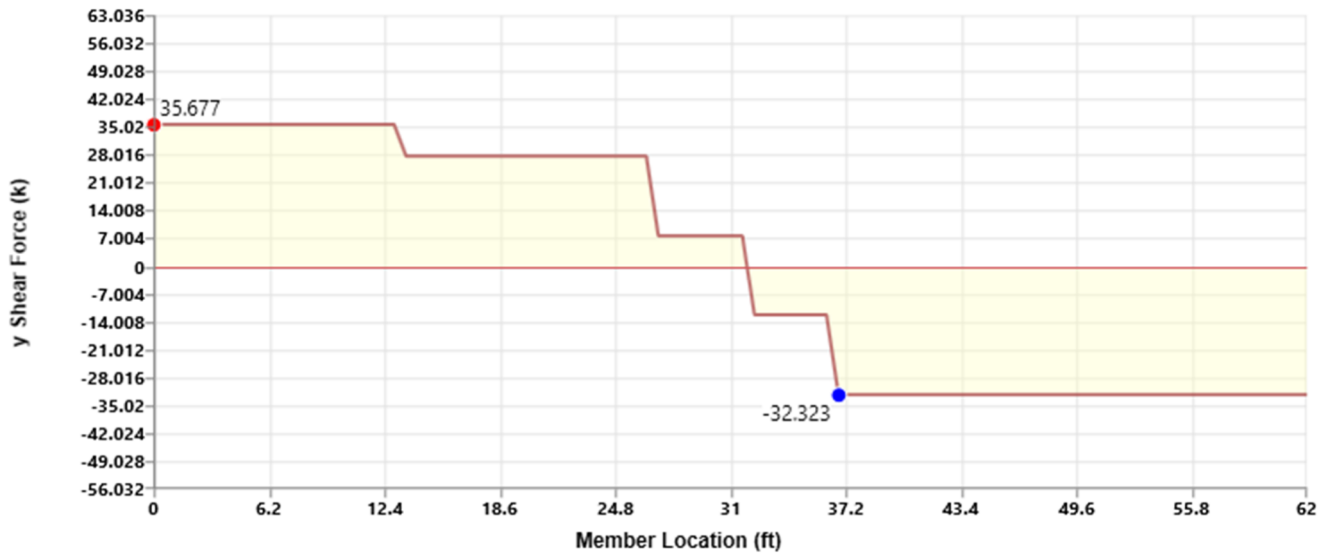
Figure 5 – Envelope shear diagram – Proposed loading

As shown above, shear demand is less for the proposed configuration than for the original HS20-44 design. The moment demand is greater but only by approximately 5%. It is PSE’s opinion that the loads imposed by the proposed transport vehicle (see Figure 7 below) are within a reasonable margin of the original design loading. Therefore, the proposed live load of 128,000 pounds appears to be structurally acceptable. The proposed transport vehicle should cross the bridge slowly to limit dynamic loading to the bridge and the 128,000-pound vehicle loading should not be exceeded.

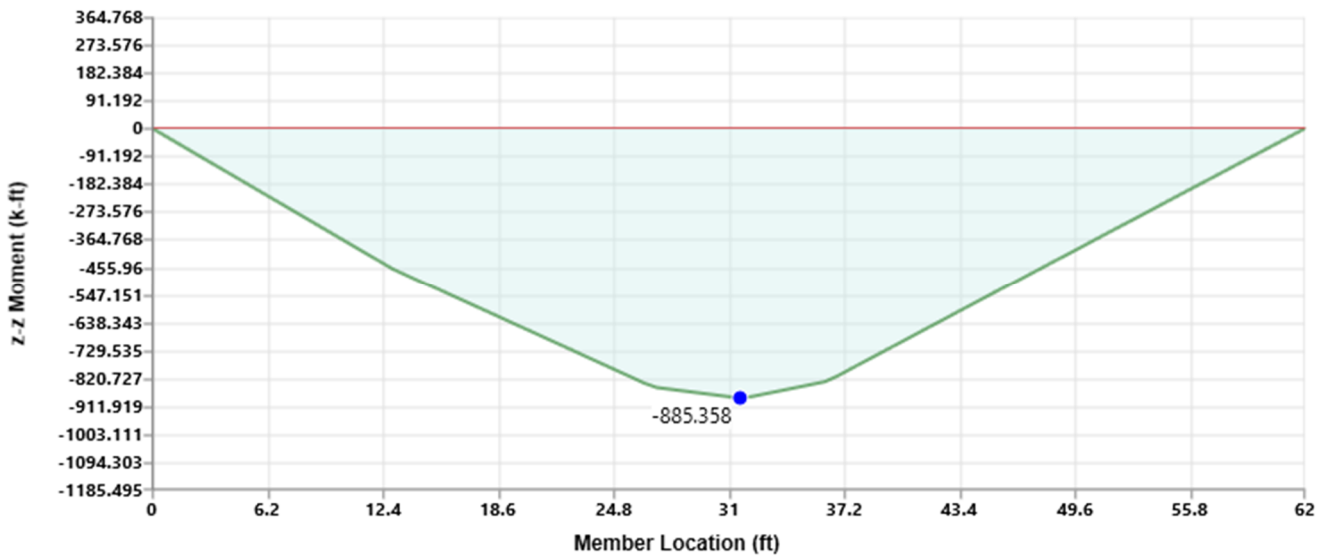
Figure 6 – Envelope moment diagram – Proposed loading

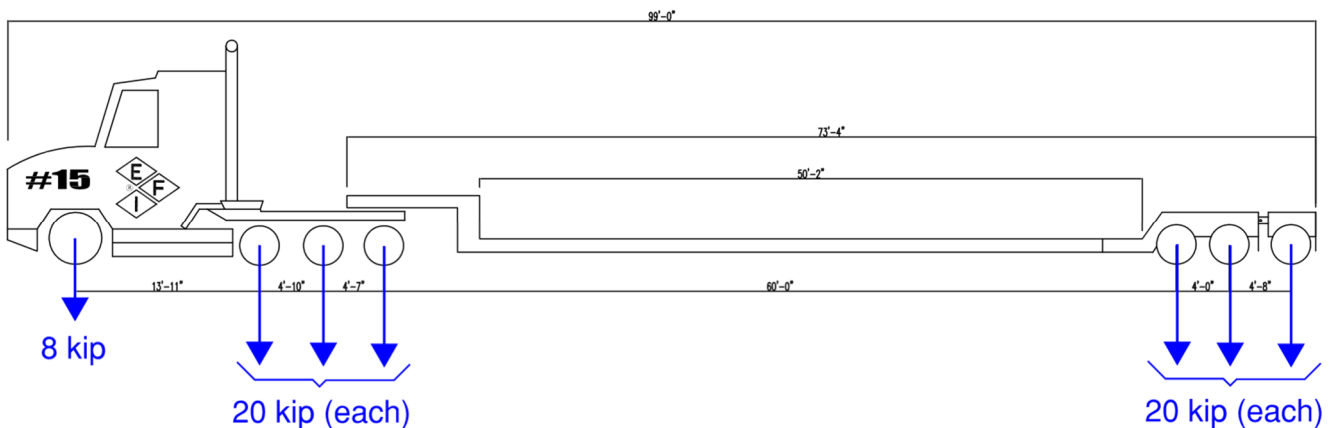
Figure 7 – Proposed Truck Loading
